DEFENSE NUCLEAR FACILITIES SAFETY BOARD

Staff Report

September 1, 2022

Reactive Materials Hazard Review at the Y-12 National Security Complex

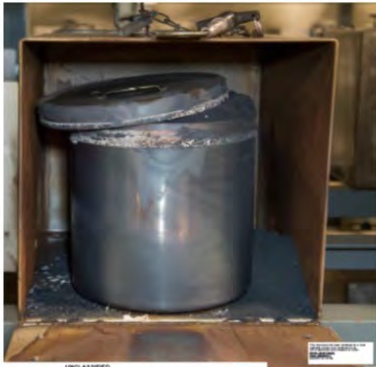
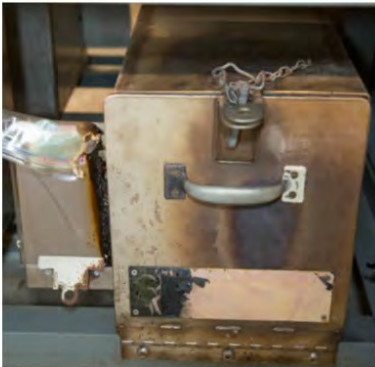
Figure 2. *Briquette Thermal Runaway Reaction Event in Storage at Y-12*

June 30, 2017	Exothermic reactions of multiple cans containing briquettes.	Fire department used thermal imaging to verify storage box was at ambient temperature before opening. Operators opened storage box and observed containers were burned and the tape seal melted.

Inner container with briquette

Outer lock box

Y-12 should improve its control strategies to prevent and mitigate uranium pyrophoric hazards and identify thermal runaway uranium reactions with sudden energy release as an initiating event for fire in its safety bases. An improved hazard analysis and control strategy could be used to reduce the likelihood of (i.e., prevent) and ensure appropriate response to (i.e., mitigate) pyrophoric events. This should include improved procedures and training to ensure responses to pyrophoric events are consistent with the guidance in DOE-HDBK-1081-2014 [7] throughout the enriched uranium processes.
