DEFENSE NUCLEAR FACILITIES SAFETY BOARD

SUBJECT: Report of Trip to Old HB-Line - Rooms 302, 304 & 306

1. **Purpose:** This memorandum reports the observations of DNFSB staff member Ajit Gwal during a visit to the Savannah River Site on March 17, 1994, to review the ventilation and fire protection systems in Rooms 302, 304 and 306 of the Old HB-Line.

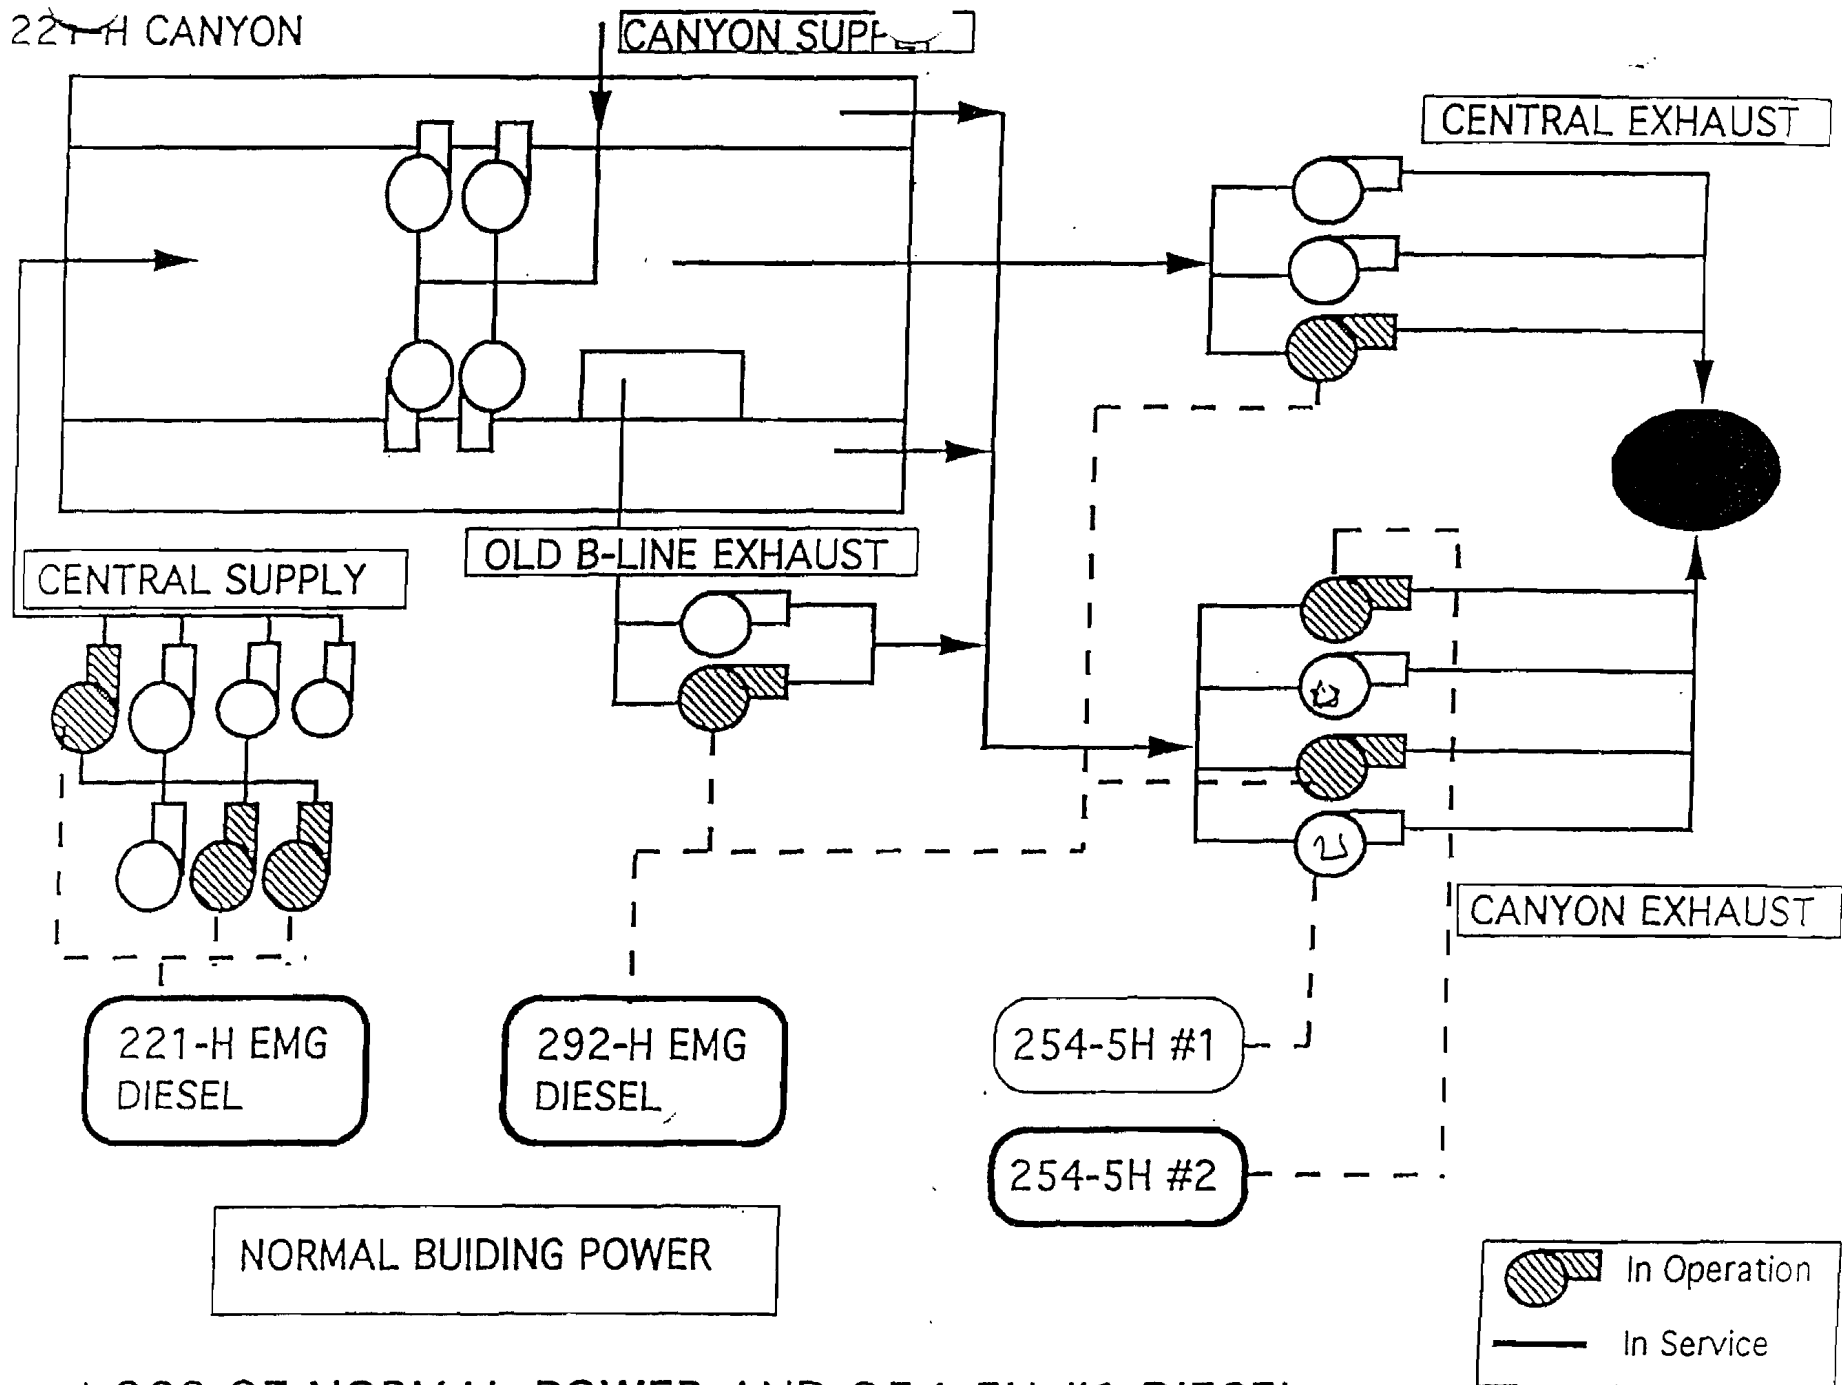
ATTACHMENT 1

4. **Discussion/Observations:** DNFSB staff observations and findings from this review are as follows:
 - a. Ventilation and power outage scenario:
 - Loss of normal power and 254-5H#1 diesel (see Attachment 1).

LOSS OF NORMAL POWER AND 254-5H #1 DIESEL

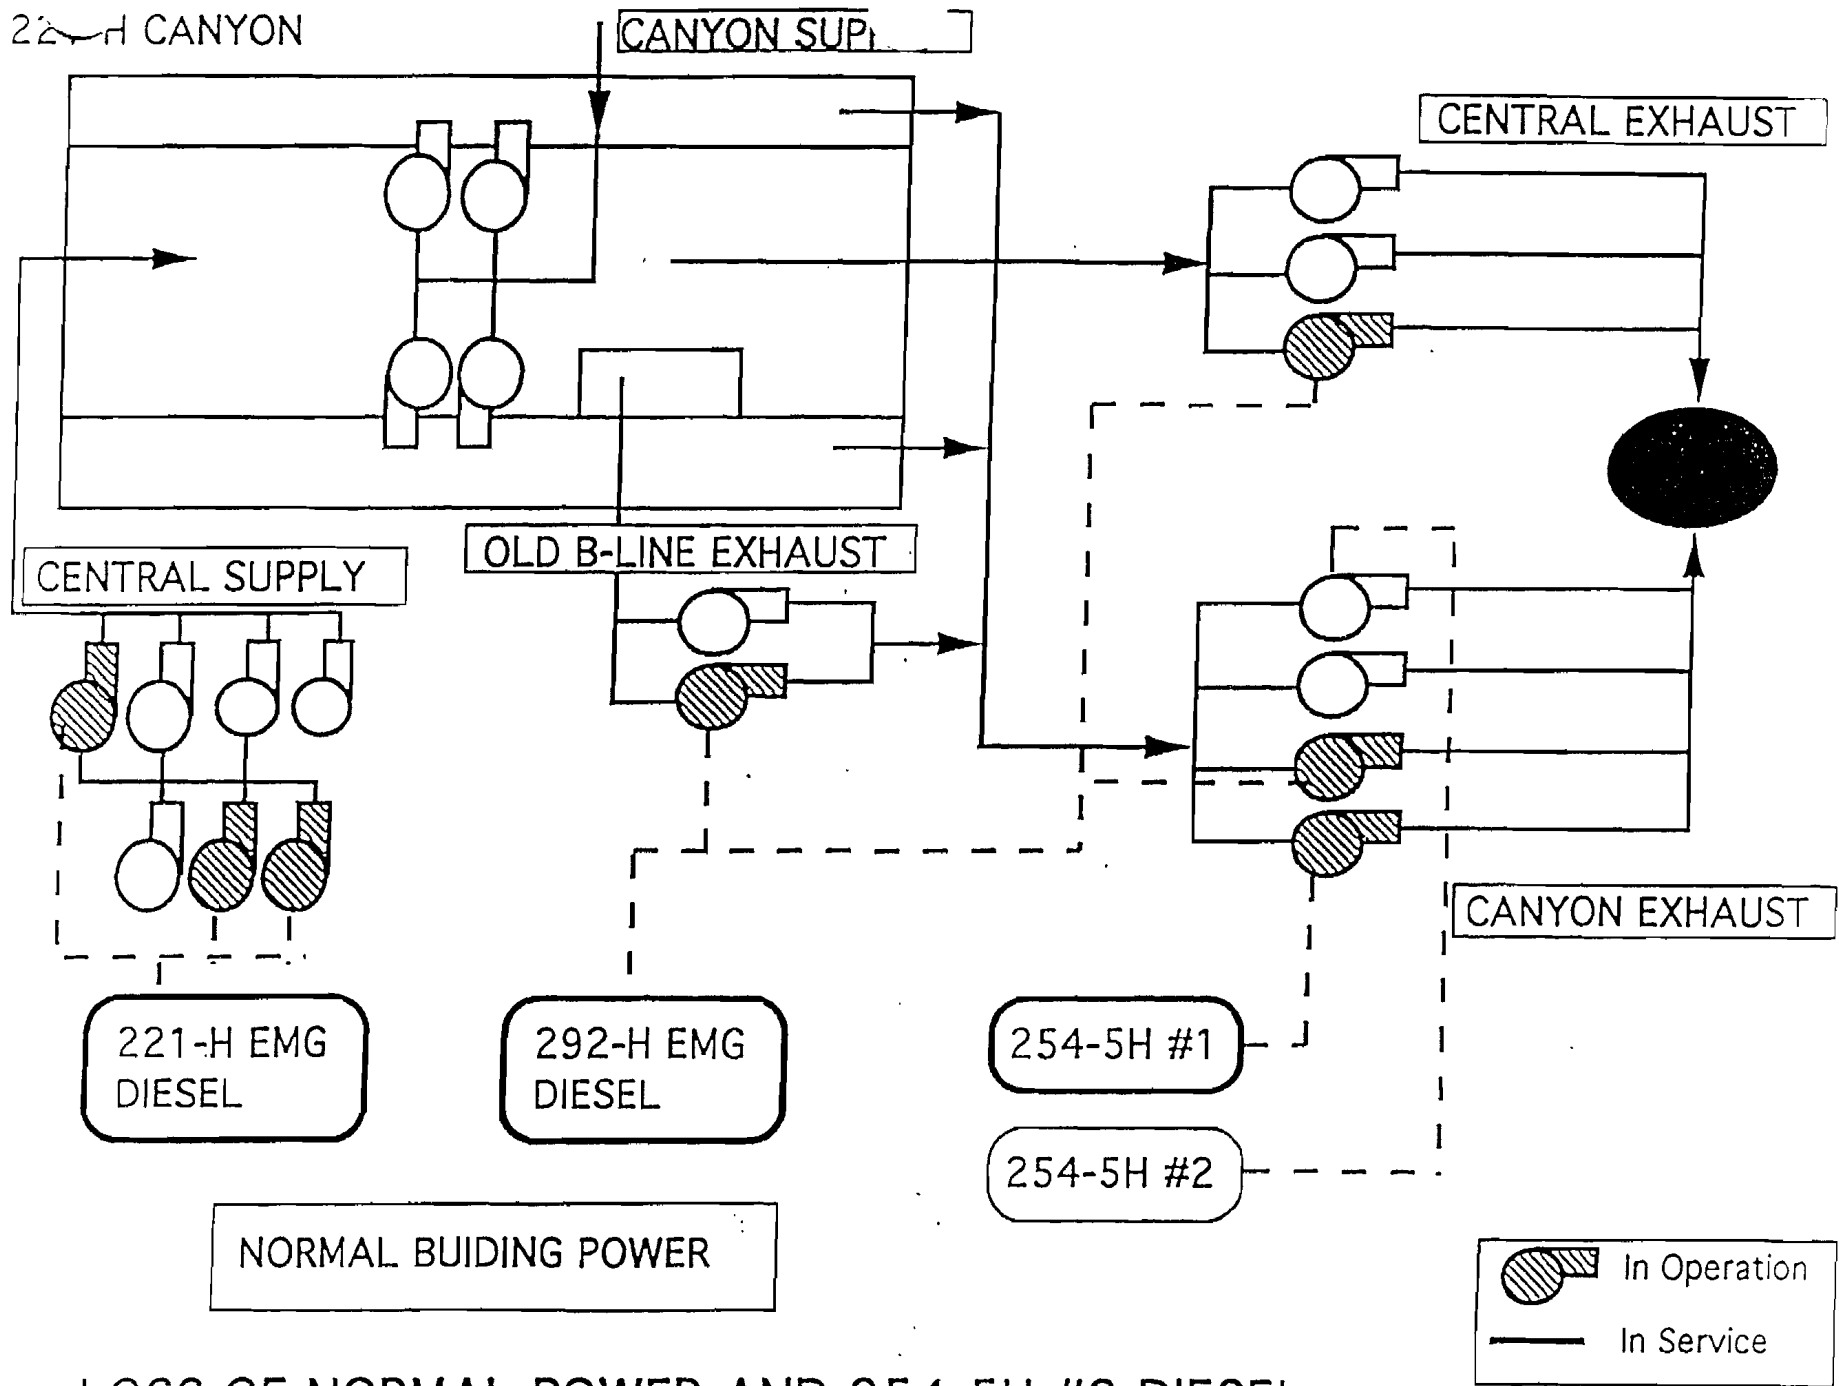
ATTACHMENT 2

- Loss of normal power and 254-5H#2 diesel (see Attachment 2).
 - Loss of normal power and 221-H diesel (see Attachment 3).
 - Loss of normal power and 292-H diesel (see Attachment 4).

LOSS OF NORMAL POWER AND 254-5H #2 DIESEL

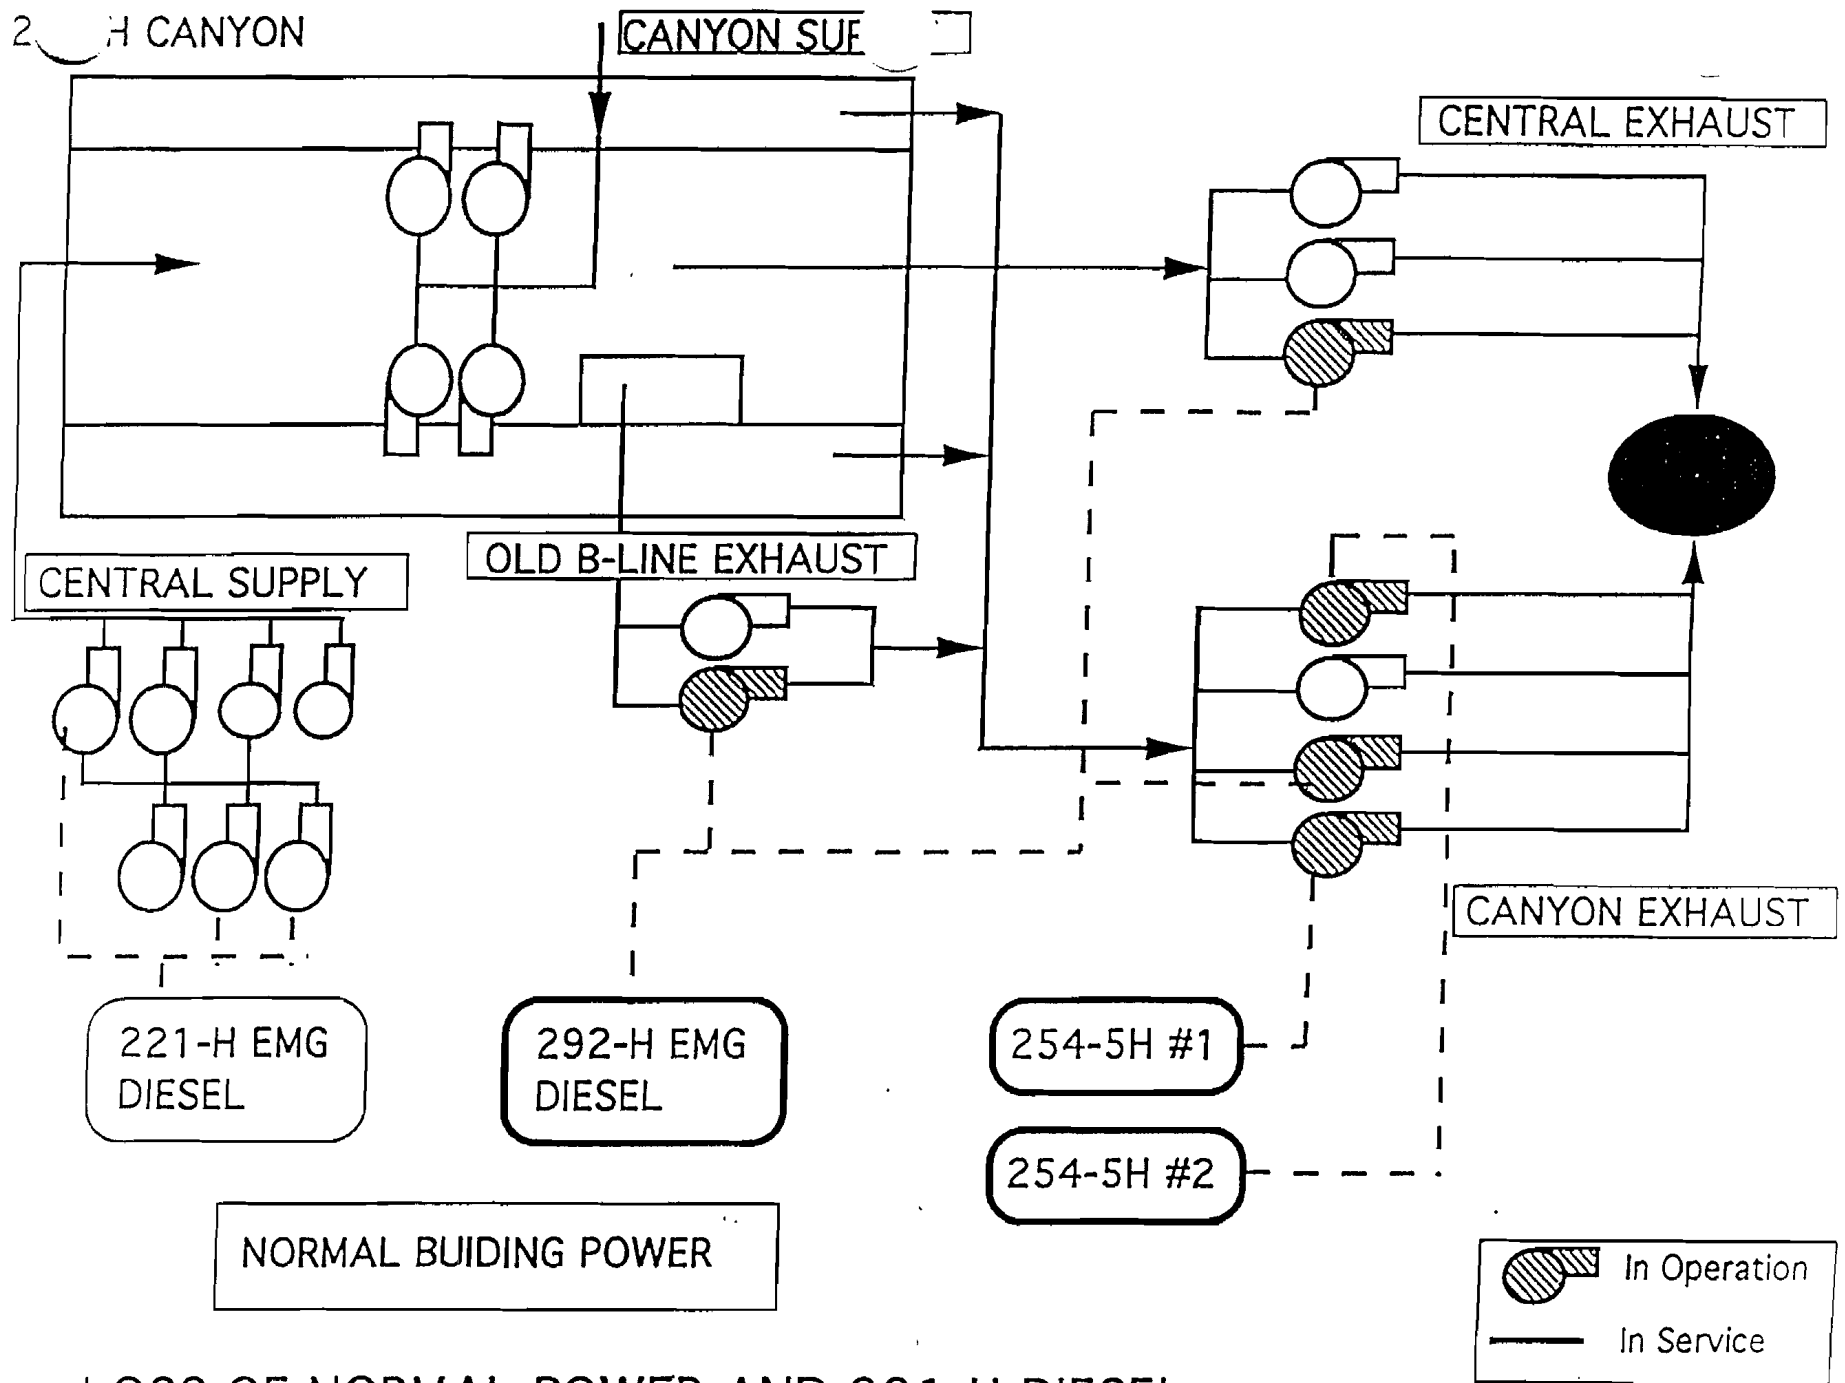
ATTACHMENT 3

LOSS OF NORMAL POWER AND 221-H DIESEL

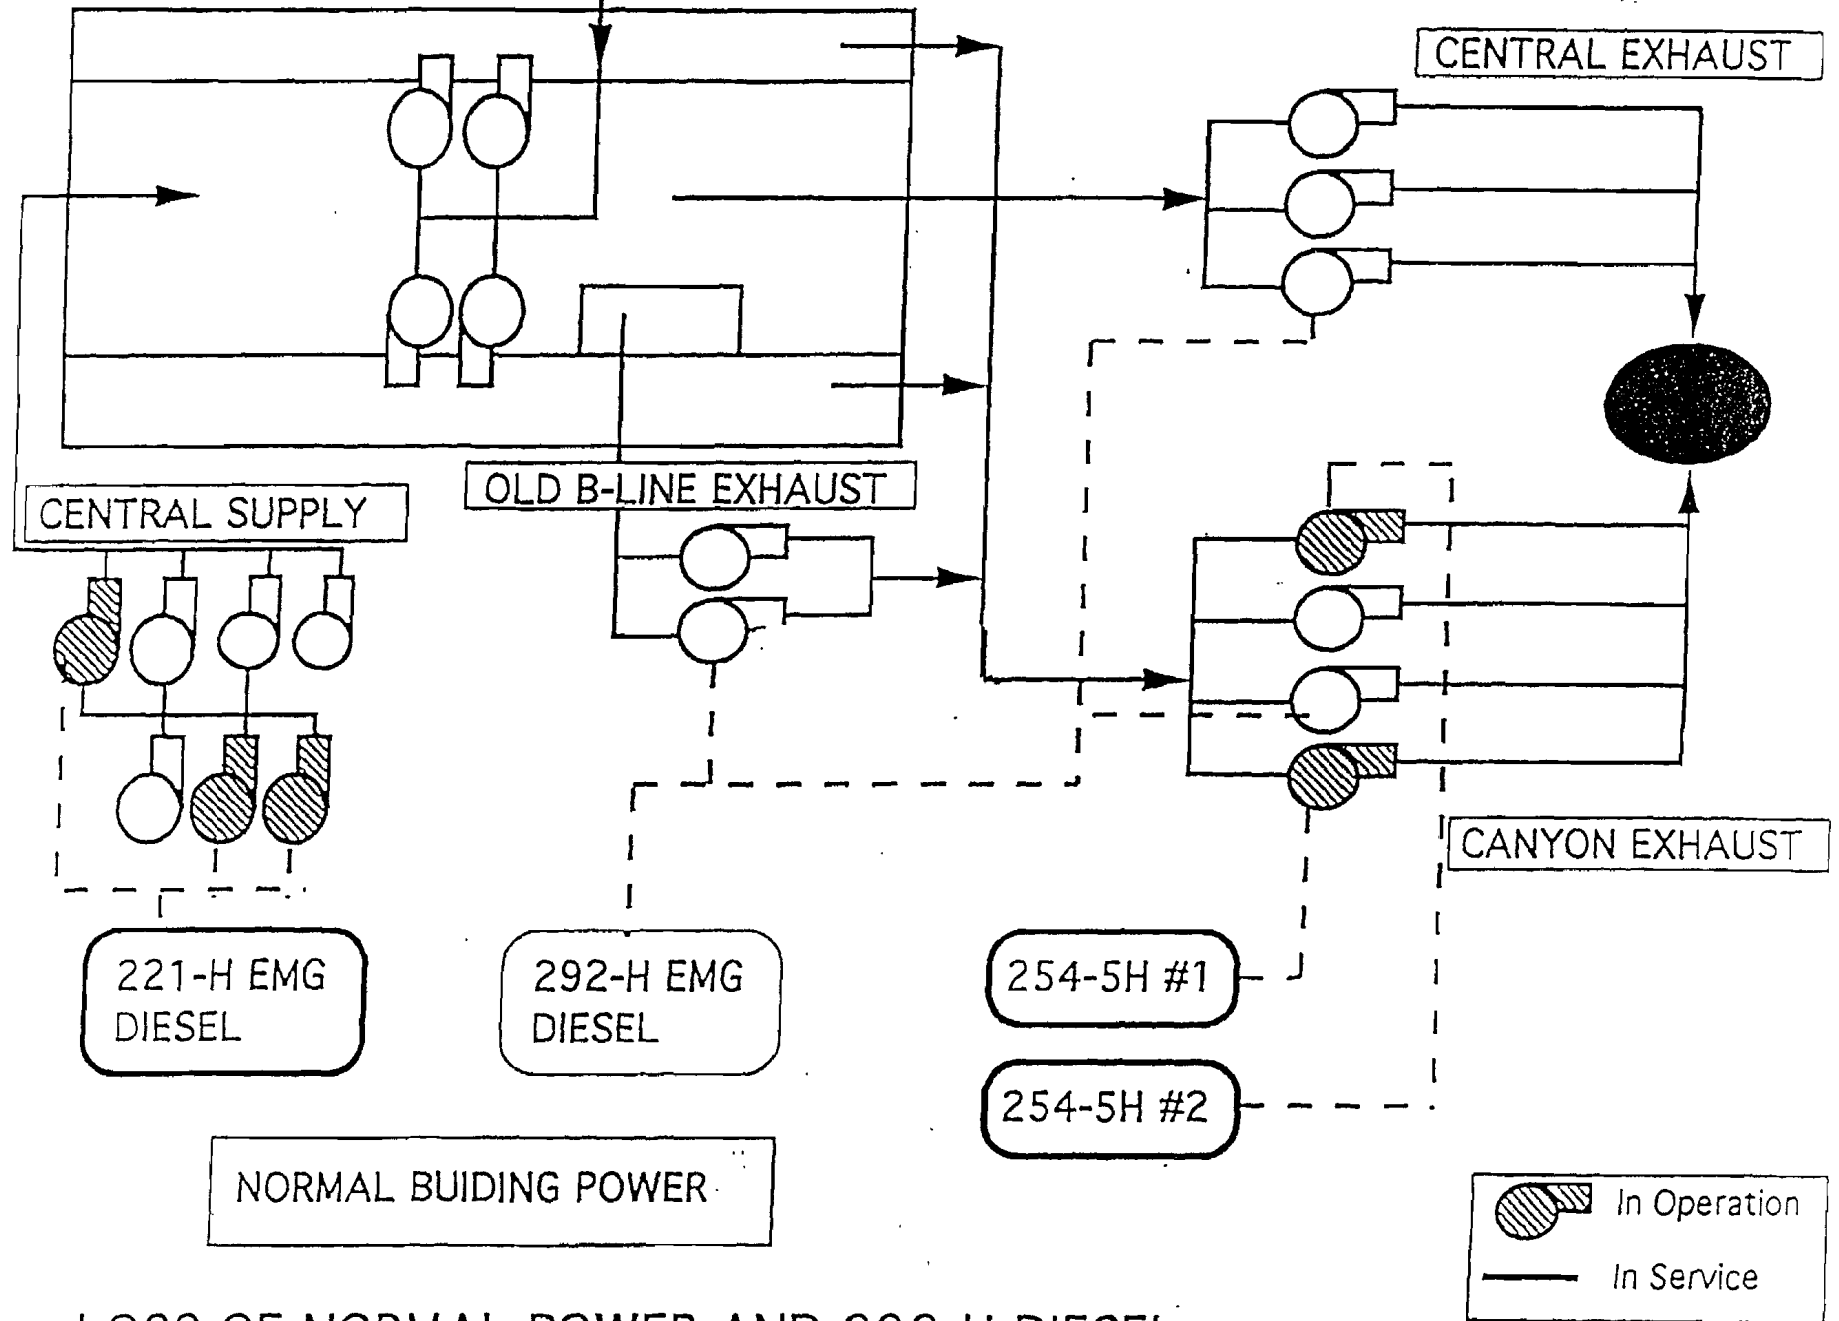
2. **Summary:** The following major issues and observations were identified:
 - a. An air flow reversal event, similar to the airborne contamination event that occurred in October 1993, will occur upon loss of normal power and the 292-H diesel.

The electrical feed configurations of supply and exhaust fans for these scenarios are presented schematically in Attachments 1 through 4. Attachment 5 provides the configuration for the normal operation of the ventilation system. Air reversal will not occur in scenarios 1 through 3. However, scenario 4 will lead to air flow reversal in room 306. It is anticipated that the Department of Energy (DOE) will evaluate this scenario and provide timely corrective action.

*AIR REVERSAL WILL OCCUR IN THIS SCENARIO

LOSS OF NORMAL POWER AND 292-H DIESEL

- a. Evaluate and implement the corrective action to prevent any air flow reversal in room 306 due to loss of normal power and 292-H diesel.
- b. Evaluate and implement the corrective action to install a fire detection system and to start fire watches.
- c. Evaluate and implement the corrective action to prevent the exposure of workers to the airborne contamination due to existing holes and cracks in the doors of room 306.

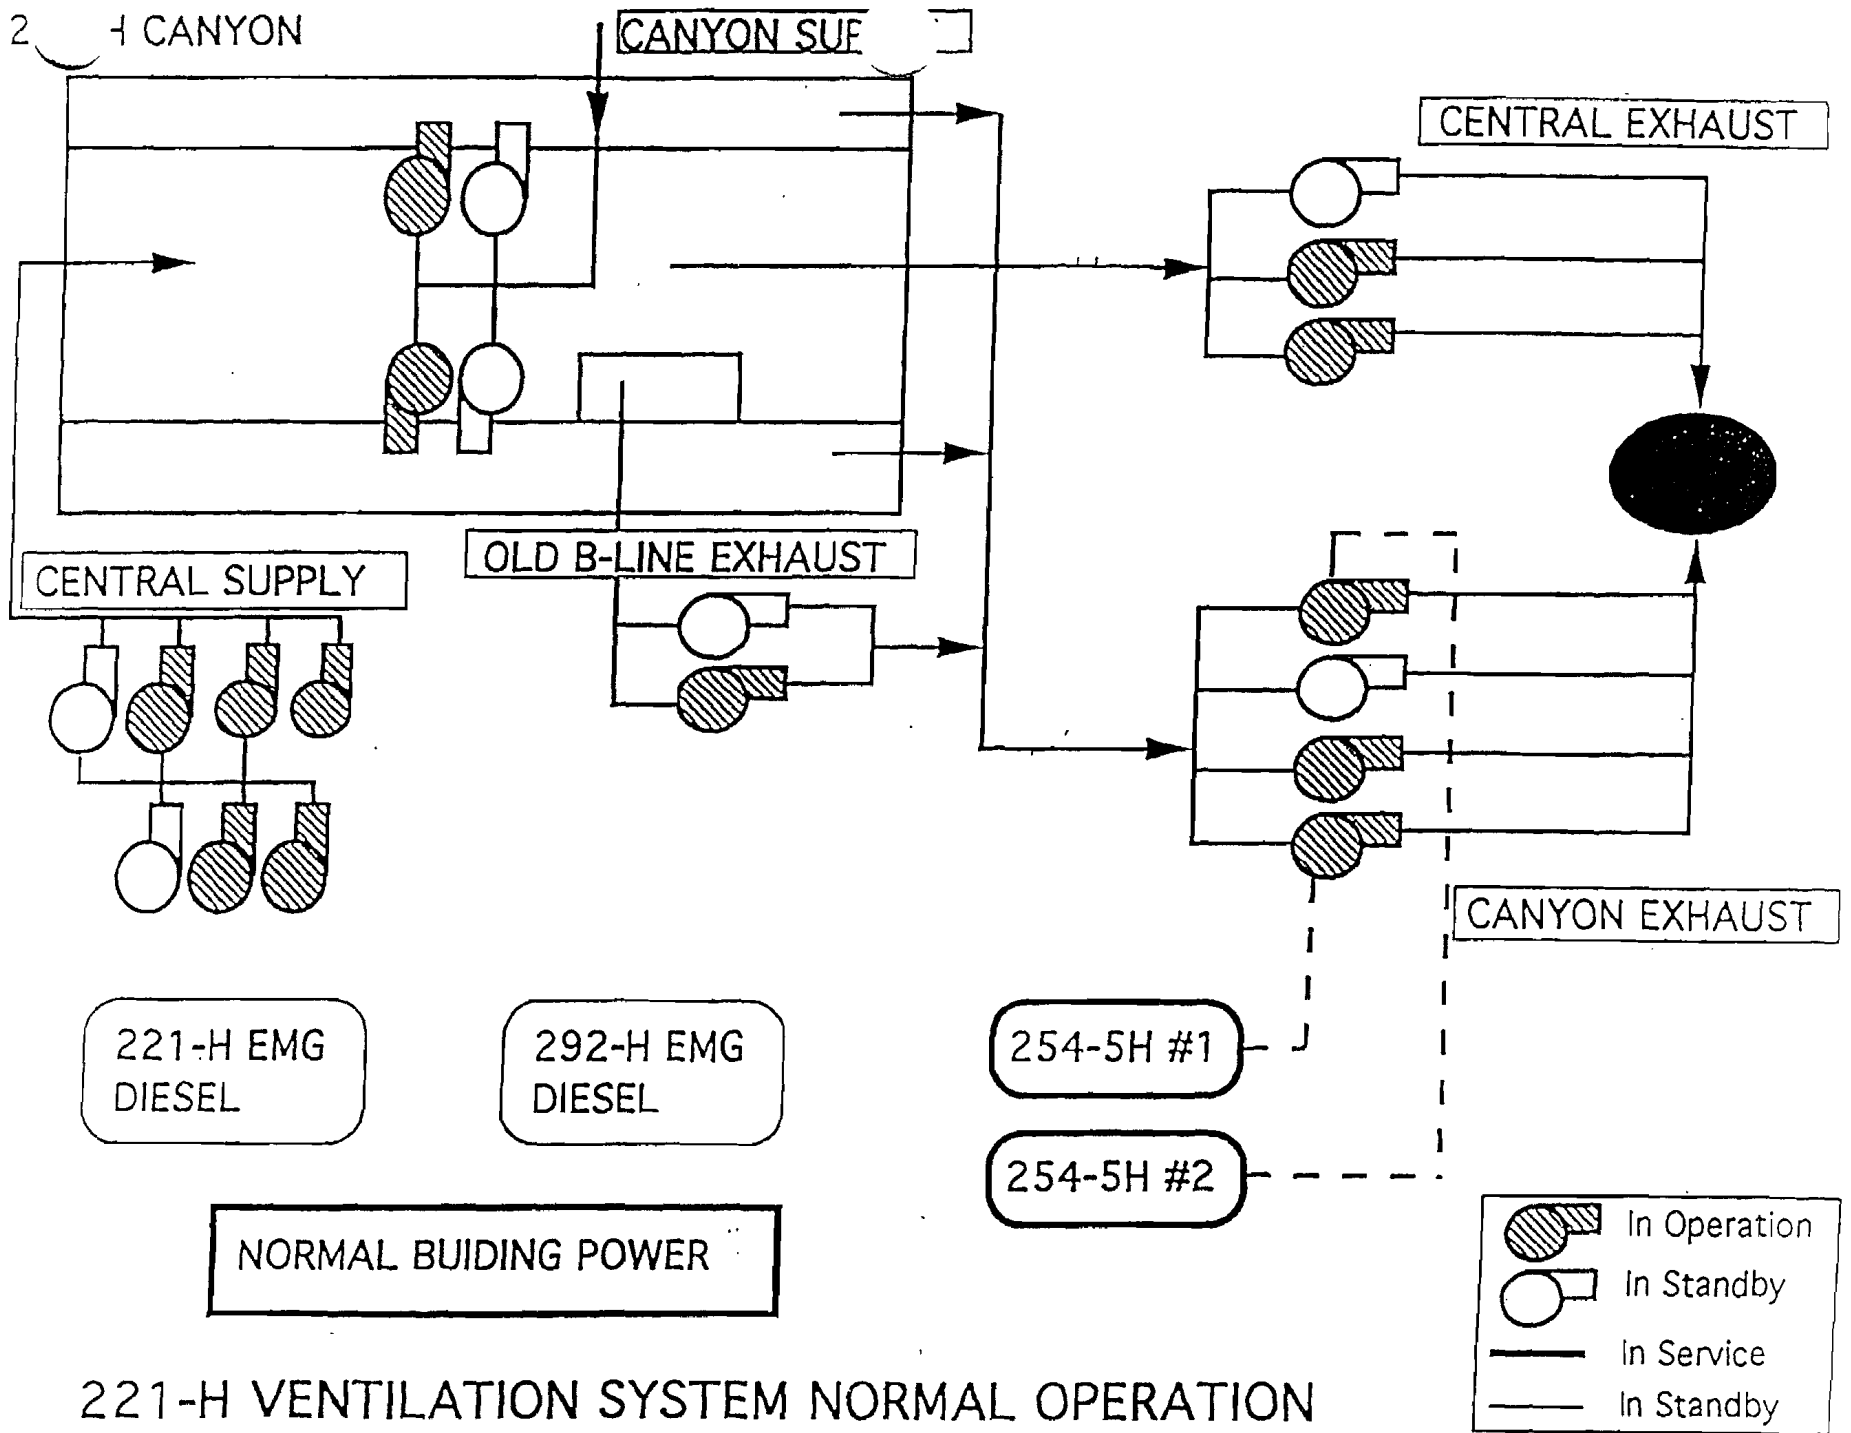
ATTACHMENT 5

- 221-H ventilation system normal operation (see Attachment 5).

221-H VENTILATION SYSTEM NORMAL OPERATION

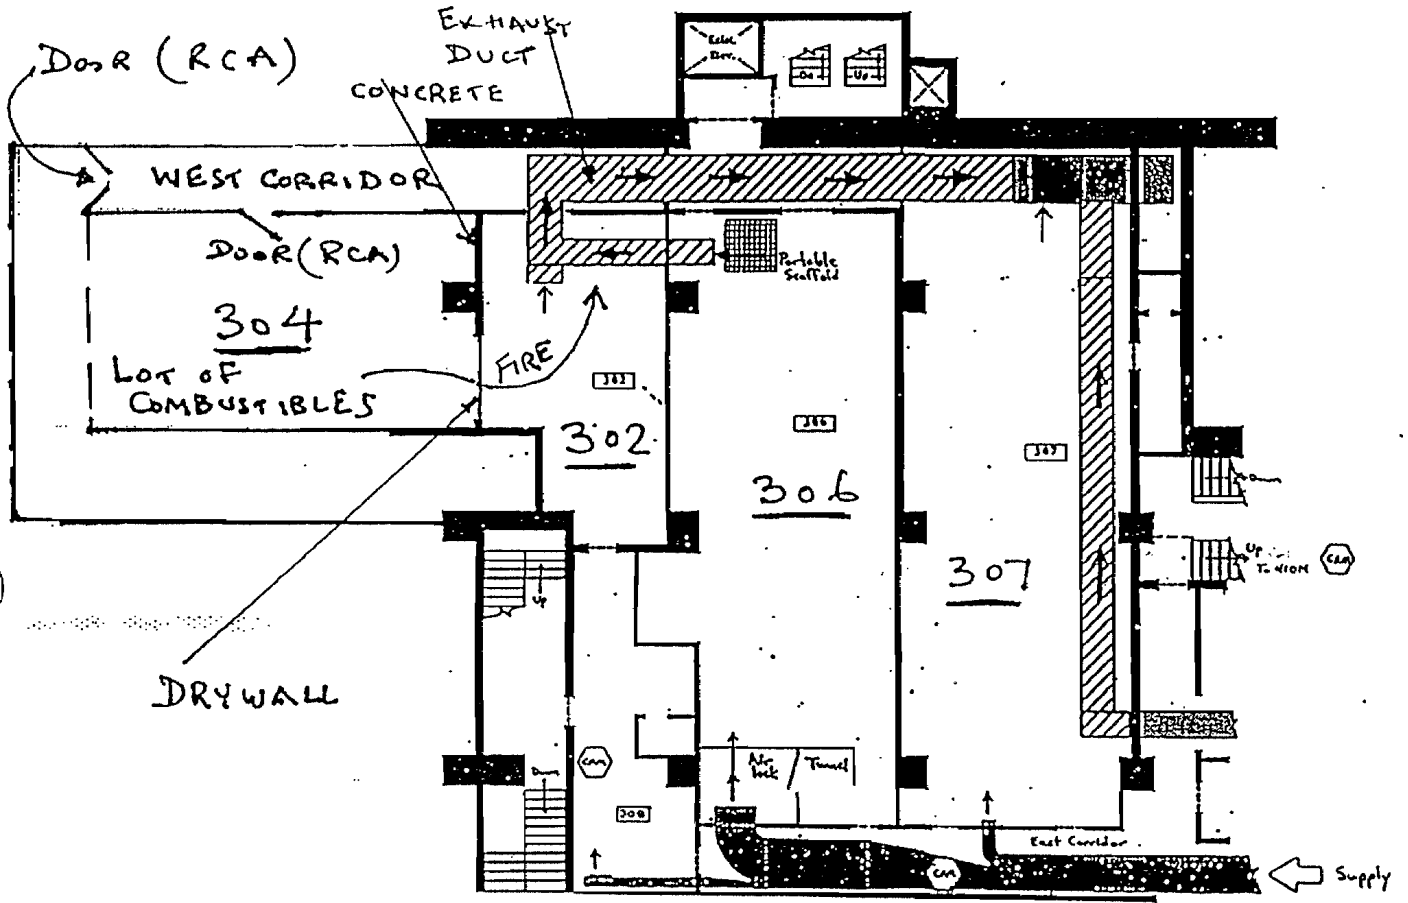
ATTACHMENT 6

- b. Room 304 contains a sufficient amount of combustible materials to create a severe fire hazard. The room contains no fire detection devices. Also, if a fire in room 304 is sufficiently intense, there is the possibility of its propagating to the adjacent room 302, with possible melting of the 16 gauge ventilation duct, and resulting in an air flow reversal and airborne contamination.

A severe fire in room 304 has the possibility of propagating through a drywall to the adjacent room 302, which contains the exhaust ventilation duct for room 306 (Attachment 6). Under such conditions there is a possibility that the 16-gauge exhaust duct material in room 306 could melt during a fire and this could result in an air reversal and airborne contamination.

- b. Fire protection: There are no fire detection devices in room 304, which contains sufficient combustible materials to create a severe fire hazard. Room 304 is not continuously occupied. The staff believes it would be prudent to have a fire detection system with an alarm in the control room and to start roving fire watches at suitable intervals of time, to detect and suppress any fire.
