**Formal Cause Analysis  
for the ARP V  
(WMF-1617) Drum Event  
at the RWMC**

**Idaho Cleanup Project Core  
Idaho Falls, Idaho 83402**

RPT-1659

October 2018

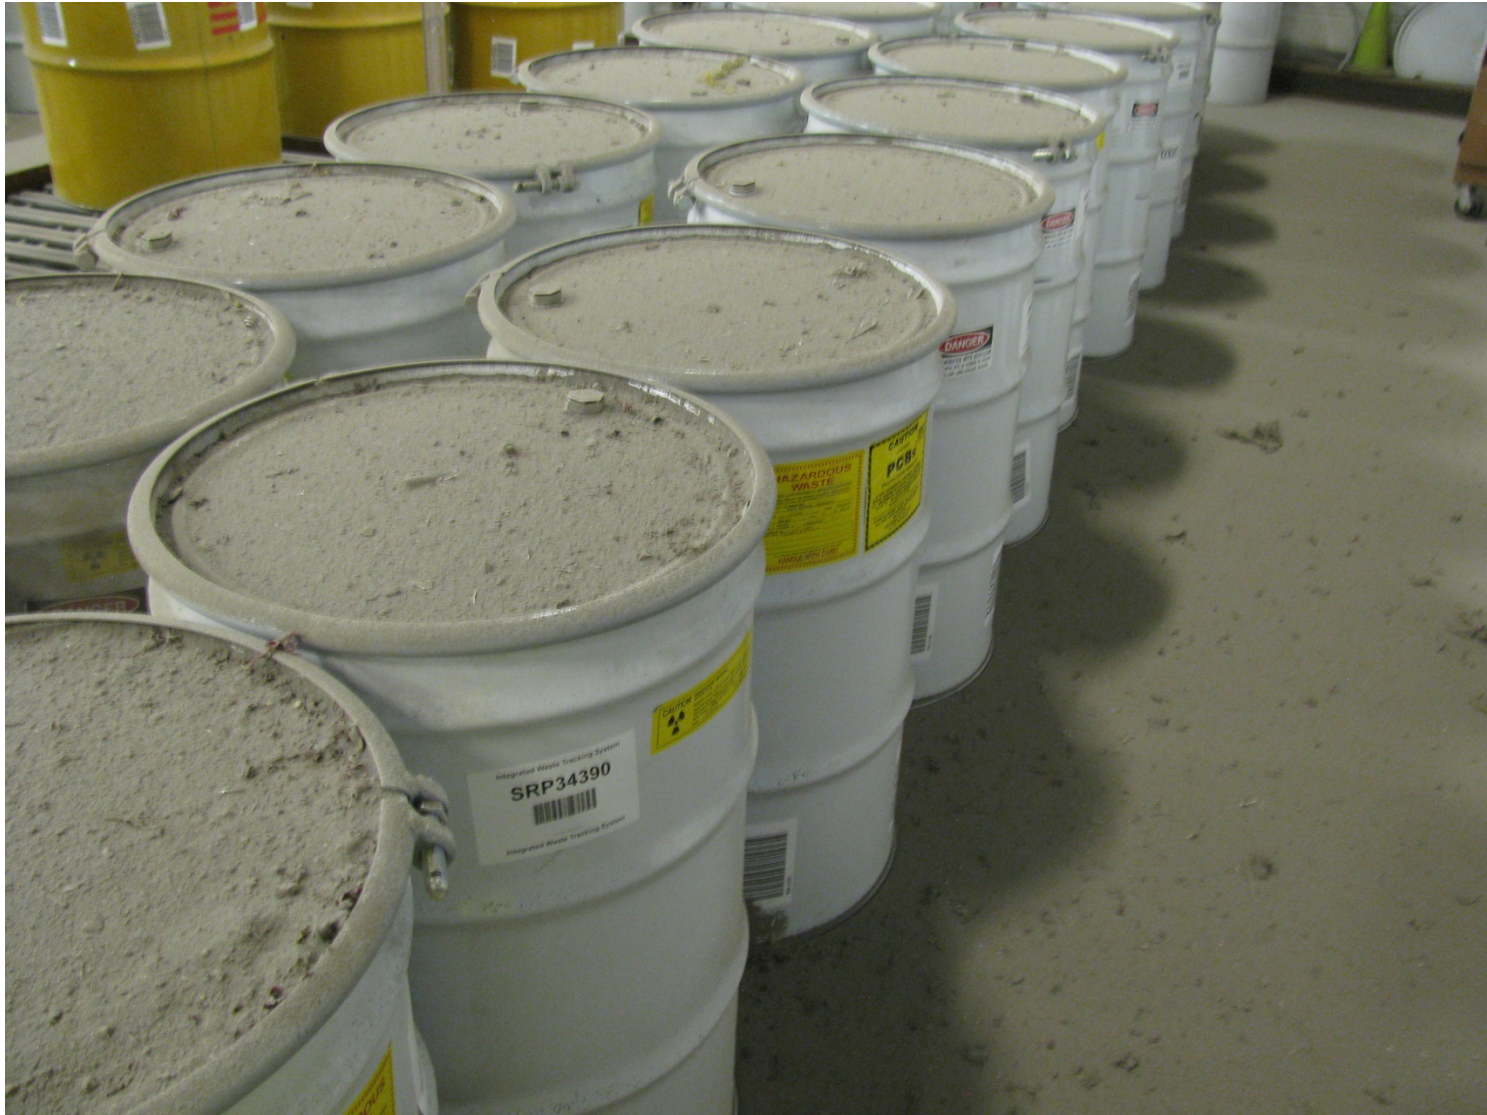
Figure 9. Drum area.

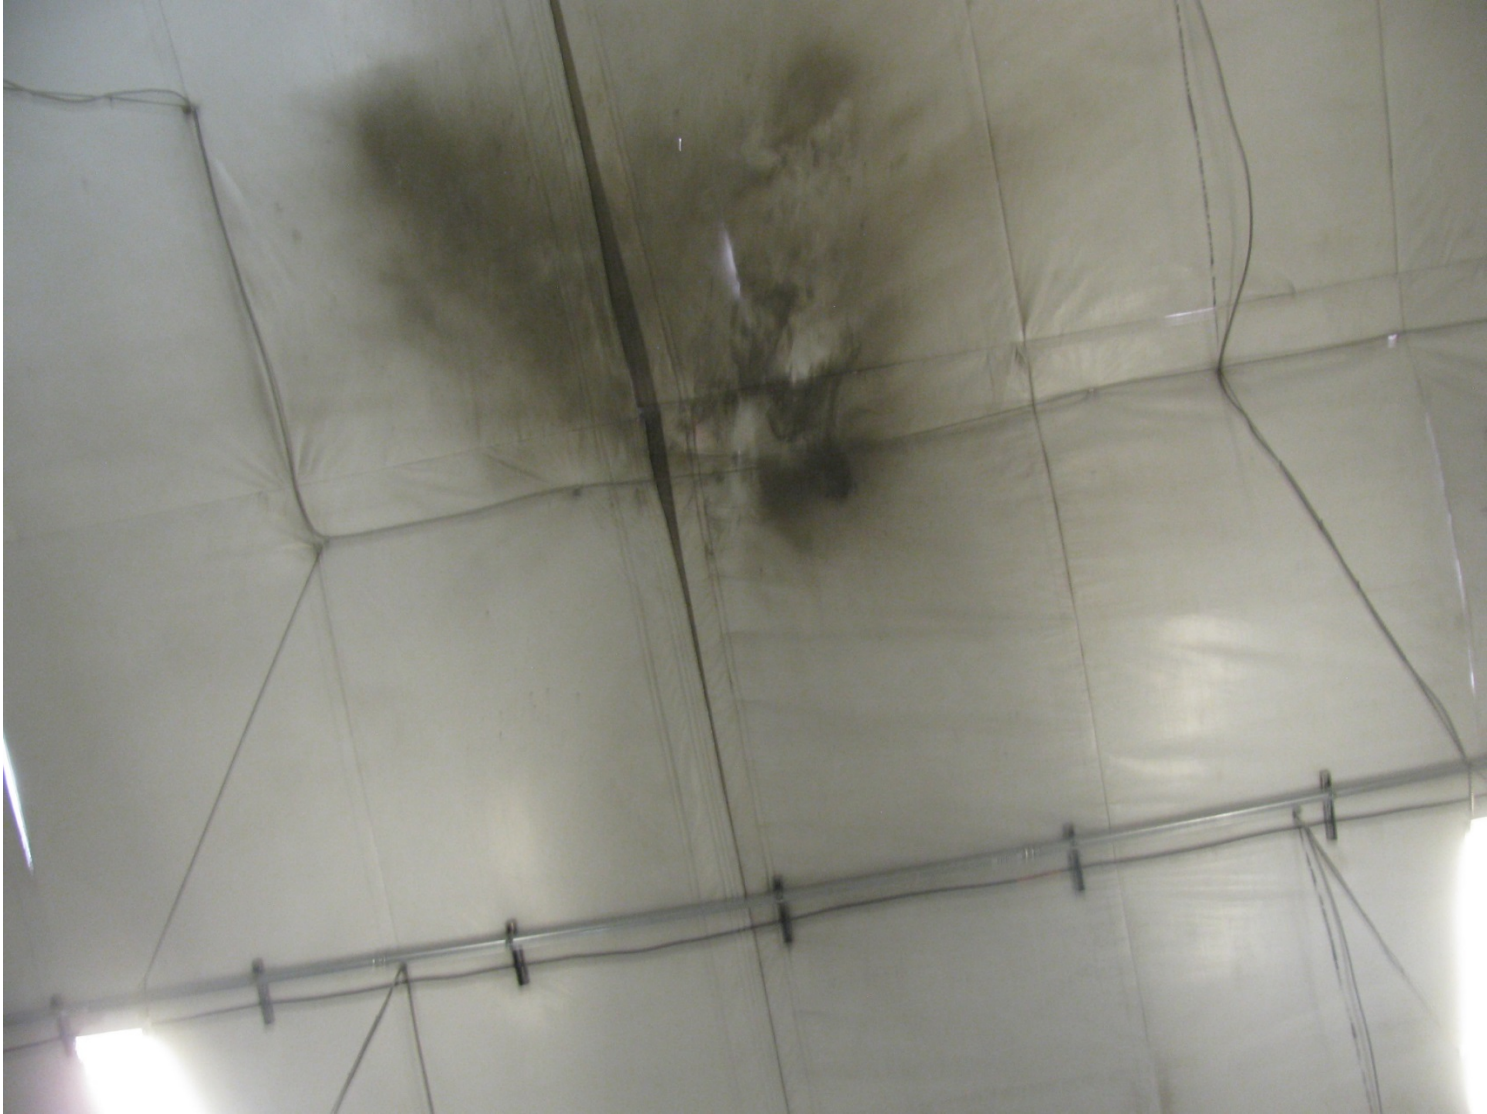
Figure 10. ARP V ceiling.

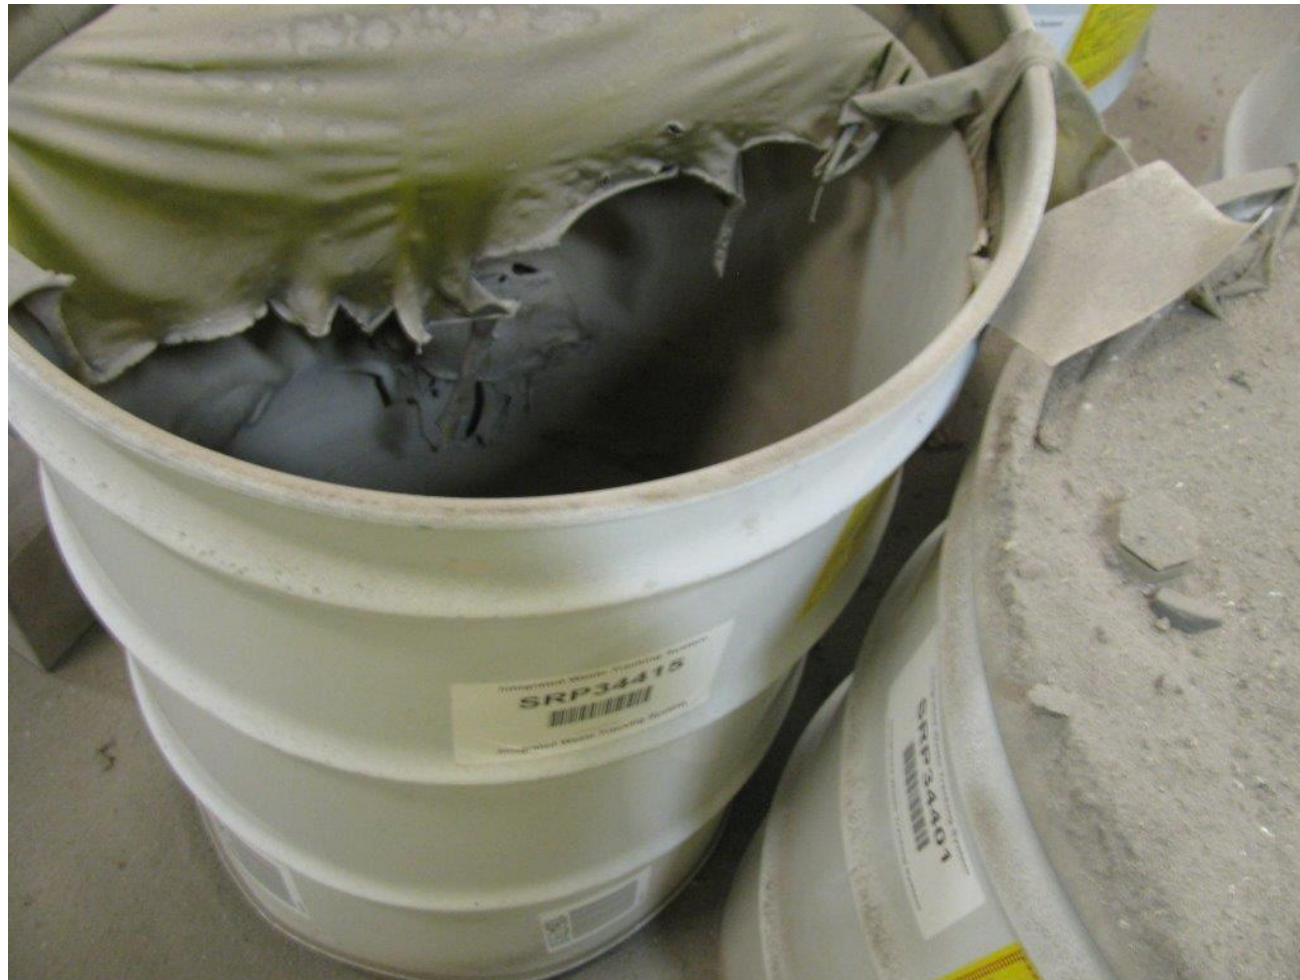
Figure 12. Drum event.

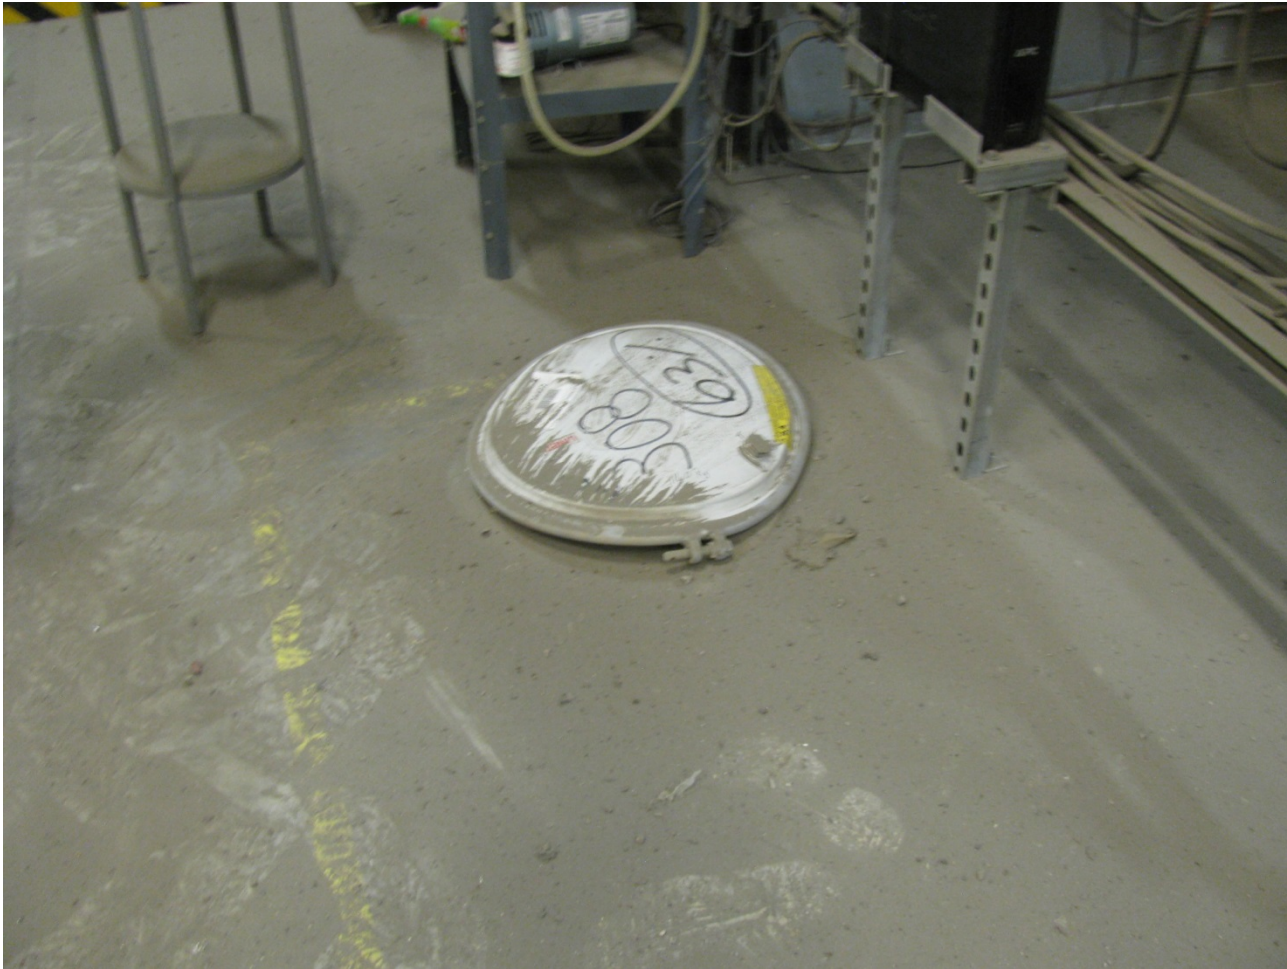
Figure 15. Drum lid.

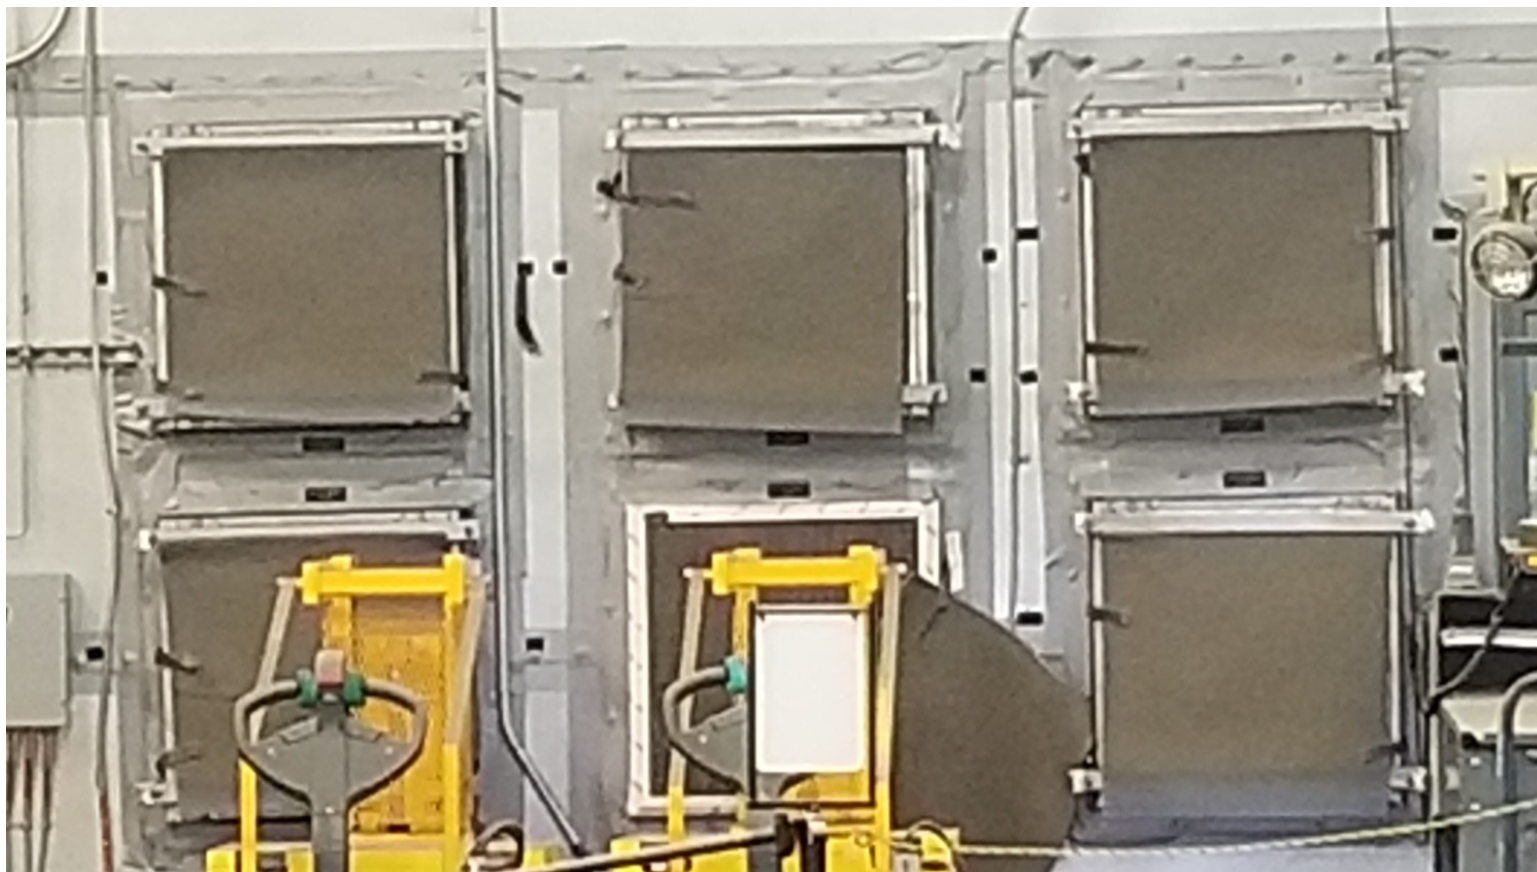
Figure 17. Ventilation pre-filters.

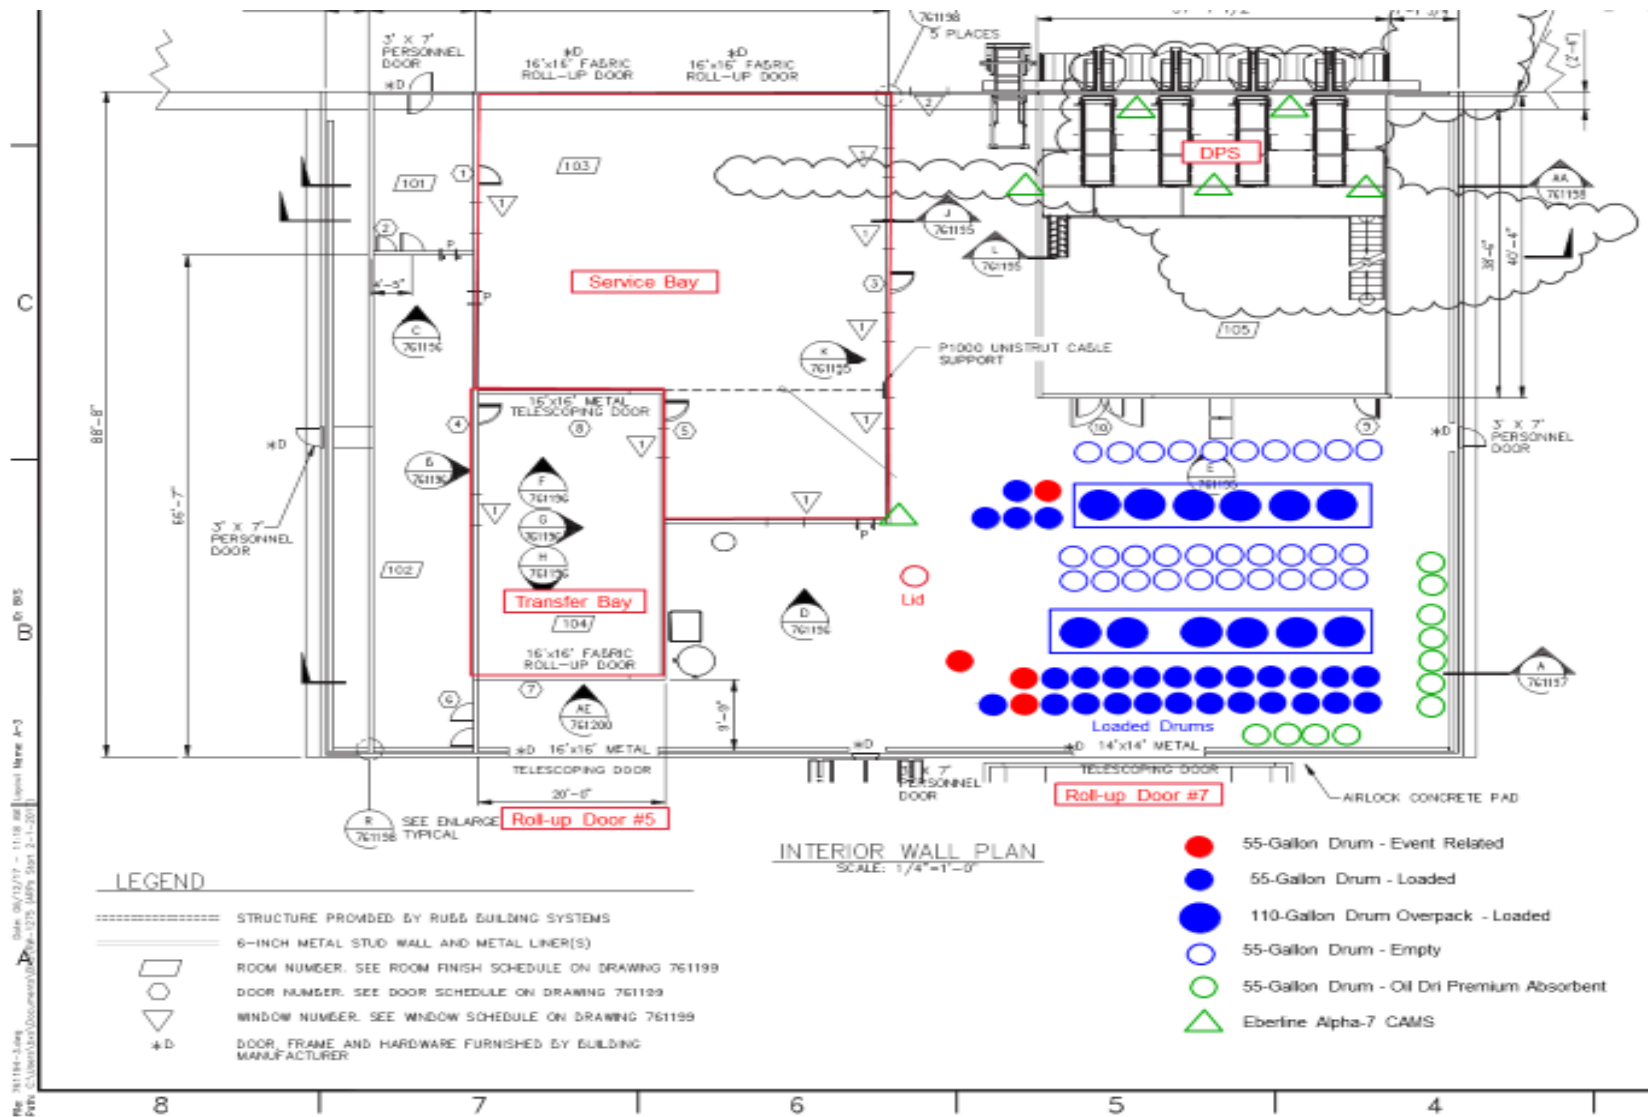
Figure 20. Post-drum layout.
