MEMORANDUM FOR: G. W. Cunningham, Technical Director**COPIES:** Board Members**FROM:** J. W. Troan**SUBJECT:** Report on the Radiation Protection Review at the Rocky Flats Plant

1. **Purpose:** This memorandum documents the Defense Nuclear Facilities Safety Board (DNFSB) technical staff and outside expert trip to the Rocky Flats Plant to review the Radiation Protection Program. The review was based on a visit to Rocky Flats on August 16-20, 1993.
2. **Summary:** The staff reviewed the Radiation Protection Program for consistency with Department of Energy (DOE) Order 5480.11, *Radiation Protection for Occupational Workers*, DOE Notice 5480.6, *Radiological Control*, and DOE Order 5400.5, *Radiation Protection of the Public and the Environment*.

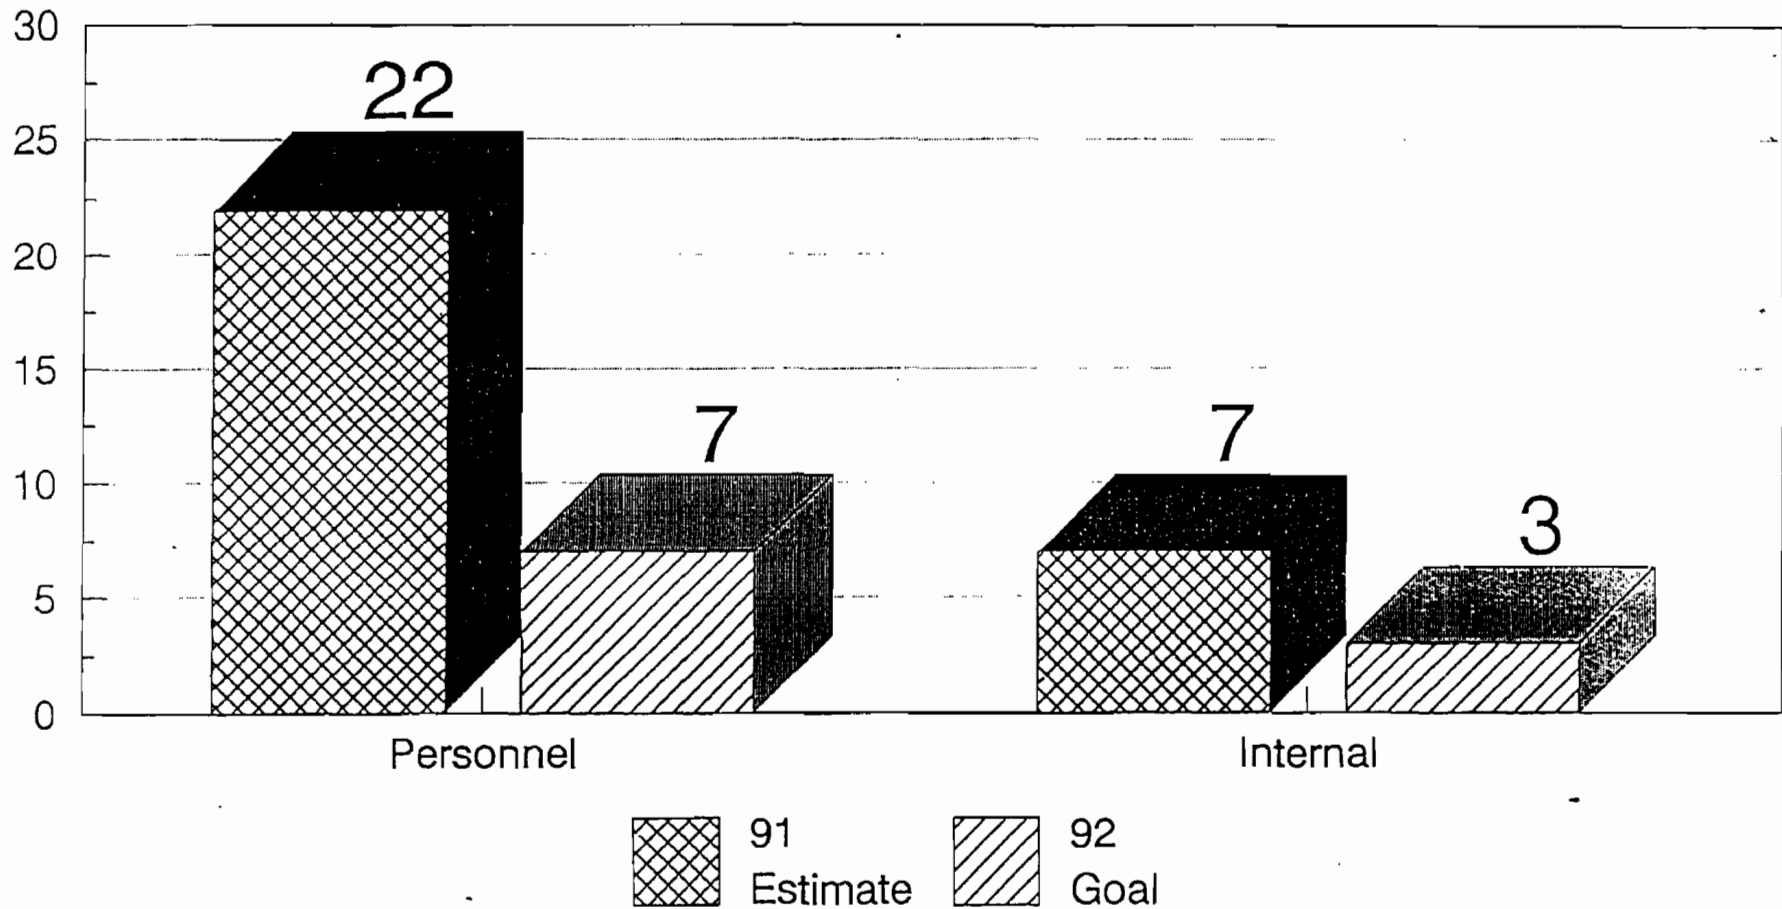
Personnel/Internal Contamination Totals

Contaminations
