**DEFENSE NUCLEAR FACILITIES
SAFETY BOARD**

Staff Report

April 7, 2022

Savannah River Site 296-H Tritium Stack Structural Review

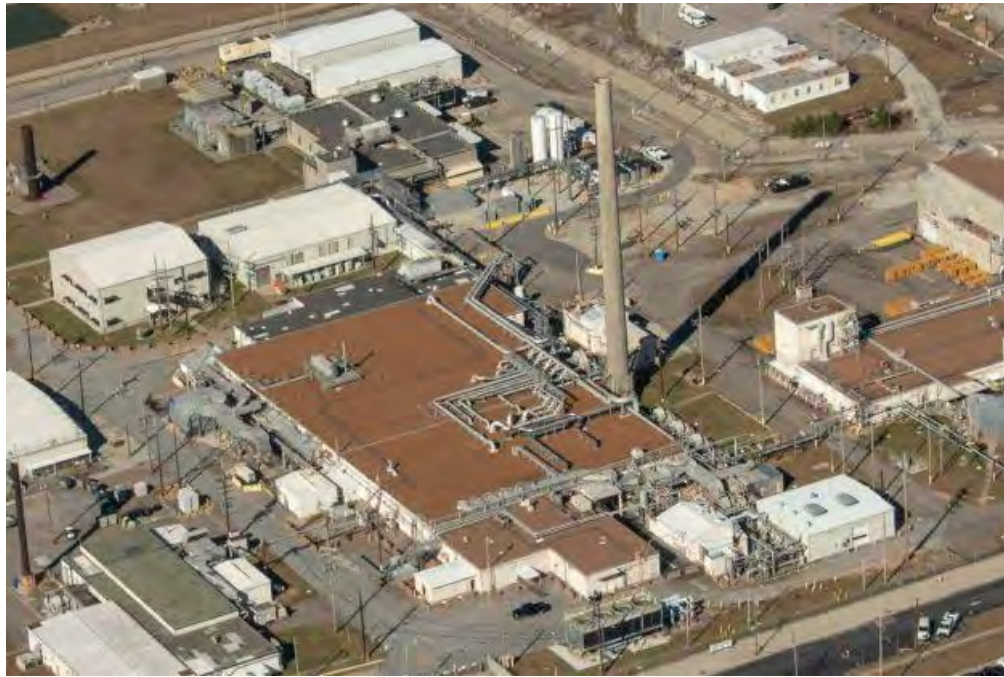
296-H Stack—The 296-H stack at SRTE was constructed in 1956 and is the primary ventilation exhaust stack for Building 234-H. The stack is located close to the east side of Building 234-H and is approximately 147 feet from the 217-H vault. The stack is 183’8” tall above its pedestal, and its outer diameter tapers from almost 13 feet at its base to 9 feet at the top. The stack and its pedestal are constructed of reinforced concrete and are founded on a 36-foot octagonal reinforced concrete mat. Regarding steel reinforcement for the stack, there is a single vertical layer along with a single layer of horizontal confining steel; the latter is configured as spiral rings with a six-inch pitch. Lastly, due to the non-caustic nature of effluent gases, the stack does not have an interior liner. An aerial photo of the 296-H stack next to Building 234-H is shown in Figure 1.

Figure 1. *Aerial View of 296-H Stack, next to Building 234-H, at SRTE*

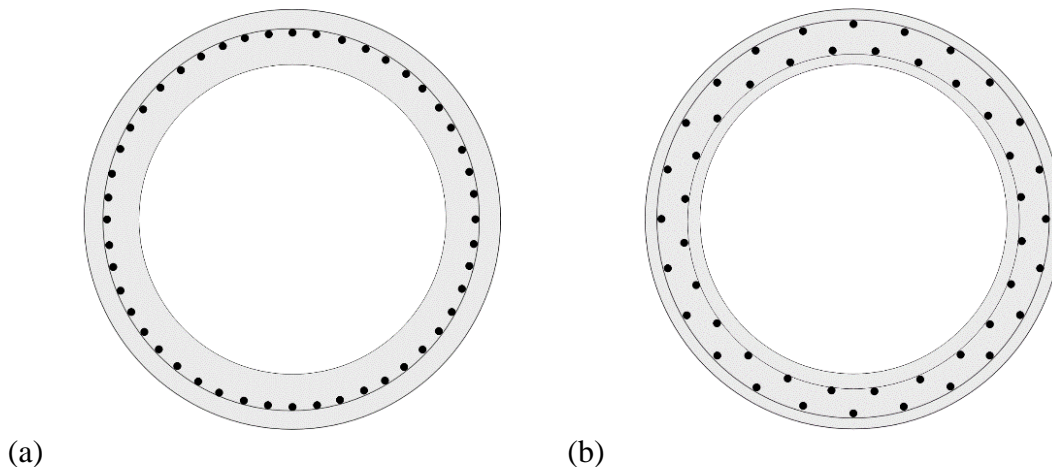
Single Reinforcement Design—Due to the vintage of the 296-H stack, it was designed with dated practices. In particular, the stack only contains one layer of vertical reinforcing steel along its length and only one layer of circumferential (confining) reinforcing steel in the horizontal direction. Figure 2 compares a single reinforcement configuration with a two-layer (“two-face”) reinforcement configuration. American Concrete Institute Standard 307-08, *Code Requirements for Reinforced Concrete Chimneys* [10], states the following in its commentary Section R4.1 (emphasis added):

Figure 2. Example Cross-sections for Vertical and Horizontal (“confining”) Reinforcement
(a) Single Layer of Reinforcement (b) Two Layers of Reinforcement (“two face”)
[Note: These are not cross-sections of the 296-H stack]

*For the 1995 edition, the Committee re-evaluated the previous exemptions regarding two-face reinforcement and minimum wall thickness for chimneys 300 ft or less in height and less than 20 ft in diameter. Recent information has indicated that two-face circumferential reinforcement is necessary to **minimize vertical cracking** due to radial wind pressures and reverse thermal gradients due to the effects of solar heating.... [T]he current committee believes that two-face reinforcement should be required in all chimney columns, regardless of size, considering the **aggressive environment surrounding chimneys**.*

interior vertical cracks since they would propagate through the thickness of the stack and be seen on the exterior of the stack. However, the Board's staff notes that interior vertical cracks may not manifest themselves on the exterior of the stack due to the presence of confining steel surrounding the vertical reinforcement.
